MARINE SURVEY REPORT — PRE-PURCHASE

1998 Beneteau *Oceanis 50*

S/V "HALCYON" · MYSTIC, CONNECTICUT

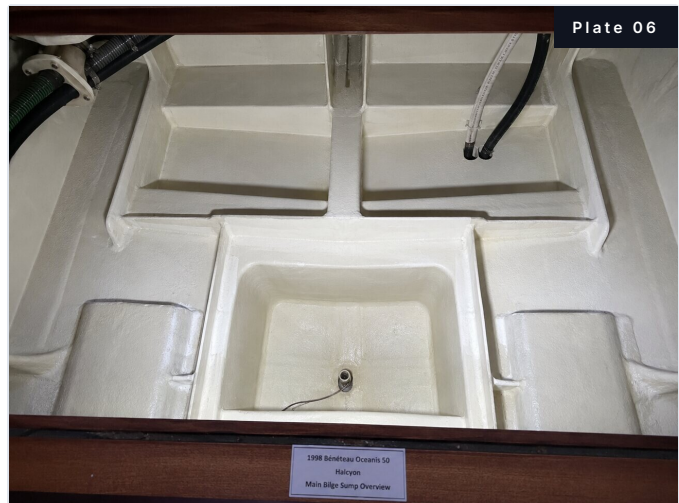
Plate 06. Moulded grid and main bilge sump, dry and clean; bonding intact.

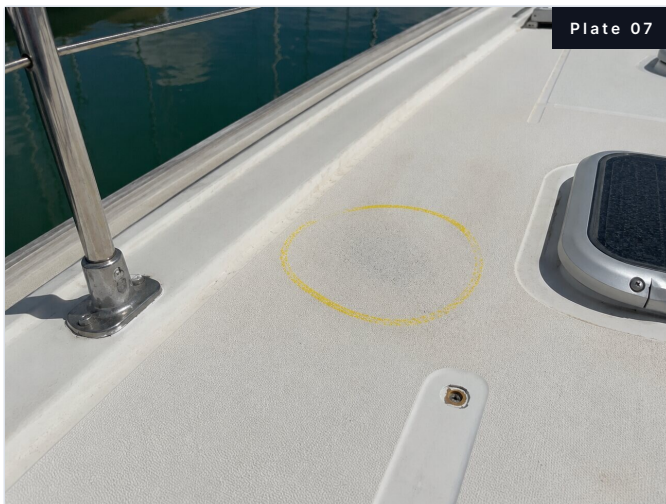
DECK ZONE	PORT	STBD	SOUNDING	ASSESSMENT
Foredeck	12	11	Solid	Dry
Side deck, forward	62	14	Dull note, port patch ≈200 mm	Elevated — Finding B-3
Side deck, aft	18	16	Solid	Dry-low
Stanchion base, aft (port)	55	15	Dull note, localized	Elevated — Findings B-3, B-4
Coachroof	13	10	Solid	Dry
Cockpit sole & seats	12	12	Solid	Dry

Both elevated areas are characteristic of moisture ingress at a deck penetration and should be opened, dried, and re-bedded. See Finding B-3.

Plate 07. Port side deck; chalk marks indicate area of elevated moisture (Finding B-3, reading 62).

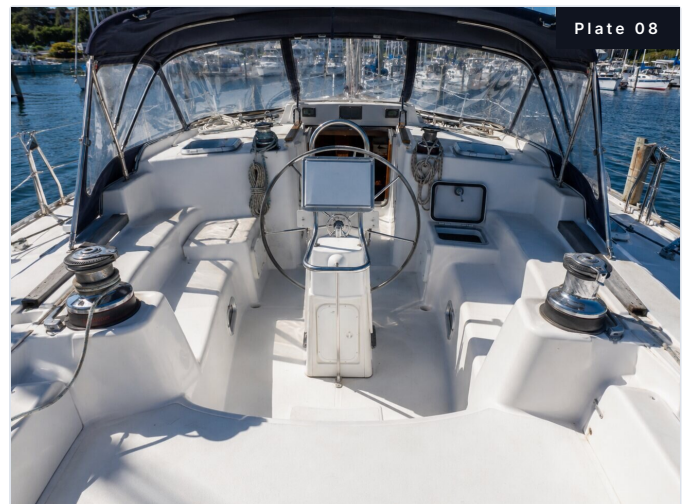
Plate 08. Cockpit, pedestal, and primary winches; coamings sound, drains clear.

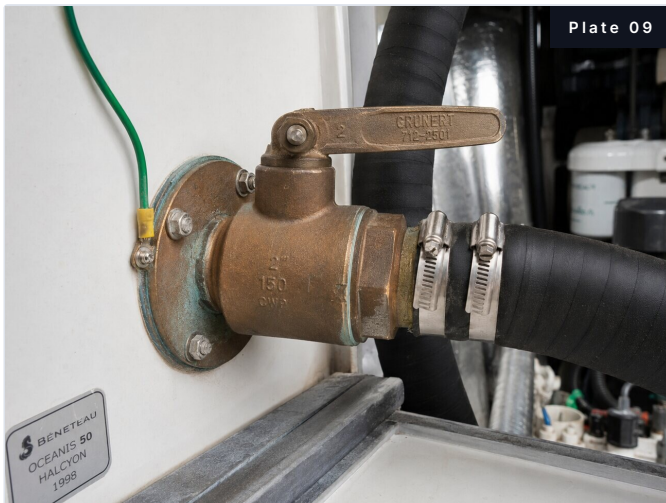
Plate 09. Representative bonded bronze seacock, engine bay; valve exercised, sound.

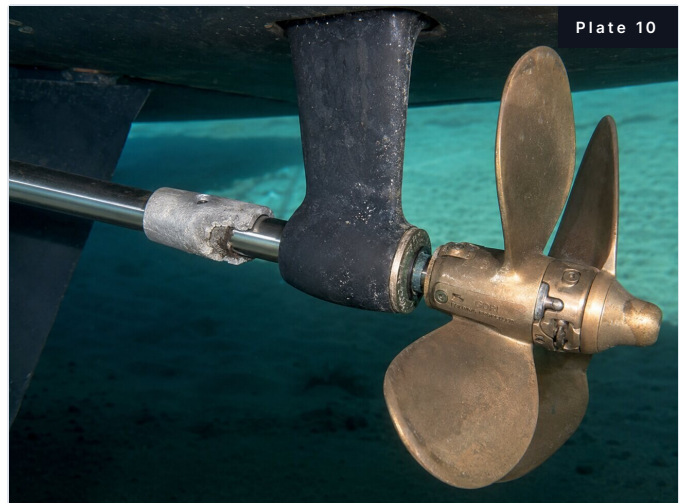
Plate 10. Shaft, folding propeller, and zinc anode; anode ~50% consumed.

A green-insulated bonding system links underwater metals to sacrificial anodes. The shaft anode was approximately half consumed — appropriate for the season and due for renewal at the next haul. The bonding system was continuous where sighted. No evidence of stray-current or galvanic distress (e.g., pink propeller, wasted fasteners) was observed. A galvanic isolator is fitted on the shore-power ground and tested functional (Section 12).

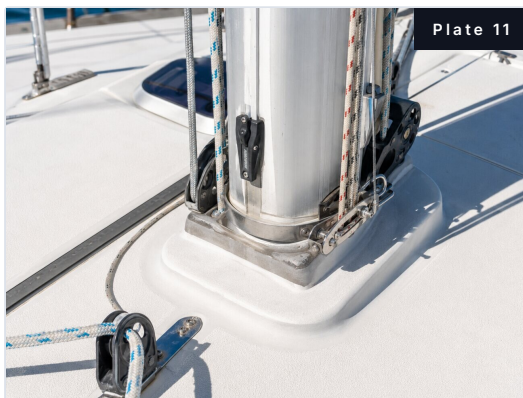
Plate 11. Mast base, collar, and deck partners; sound, no compression set.

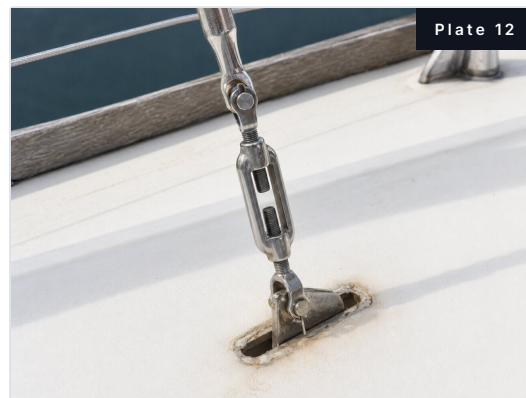
1×19 stainless wire with swaged terminals and open-body turnbuckles; cap and lower shrouds, fore- and backstay. The wire and terminals appear **original to the 1998 build**. No broken strands, terminal cracking, or heavy crevice corrosion were visible at deck level, but visual inspection cannot certify wire of this age. Thru-deck chainplates were examined where accessible; bedding sealant is aged and one chainplate shows light surface staining at the deck slot. The standing rigging is the principal action item of this survey. See Findings B-1 and B-2.

Industry practice and most underwriters assume a 10–15 year service life for stainless standing rigging, and many insurers require replacement at 15 years even for coastal cruising. At twenty-eight years, a full re-rig should be planned regardless of present appearance.

Plate 12. Starboard cap-shroud terminal; original swage, aged bedding (B-1, B-2).

| B-1 | Standing rigging original (28 yr); full re-rig recommended. |

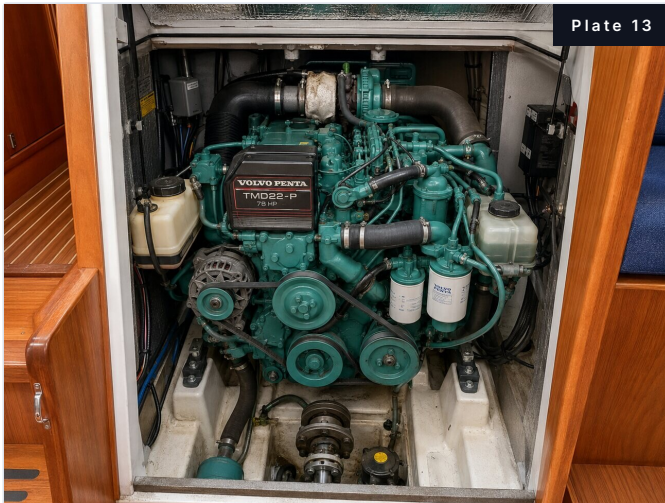
Plate 13. Volvo Penta TMD22-P in engine bay; clean, no active leaks.

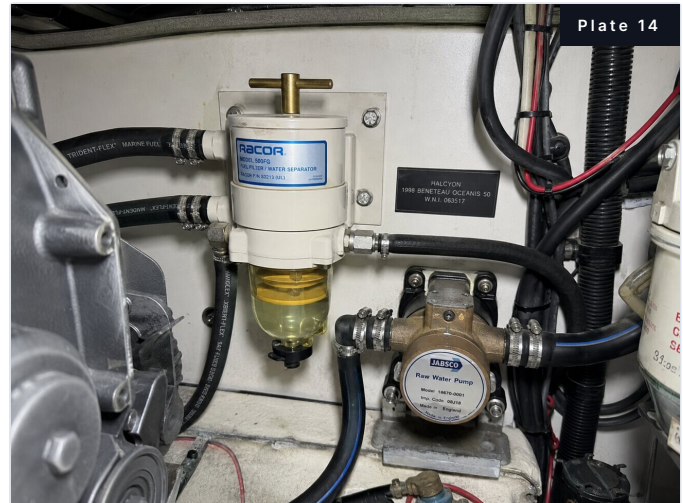
Plate 14. Racor primary separator and raw-water pump; serviceable, double-clamped.

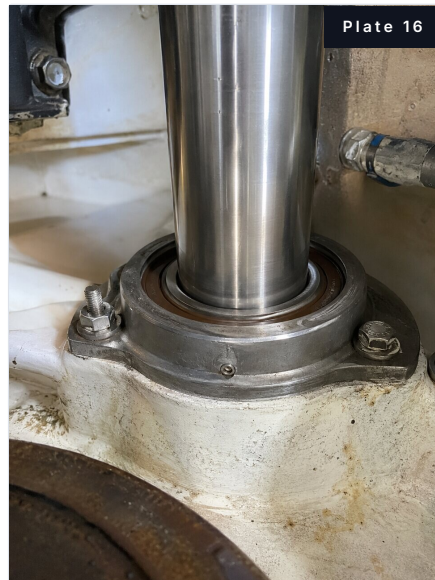
Spade rudder on a stainless stock. The blade sounded solid with no water egress at the lower trailing edge and dry moisture readings (12–14 across the blade). A slight movement was detectable at the lower rudder bearing — within tolerance for age but worth monitoring. See Finding C-3.

Plate 16. Upper rudder bearing and stock; slight play, monitor (C-3).

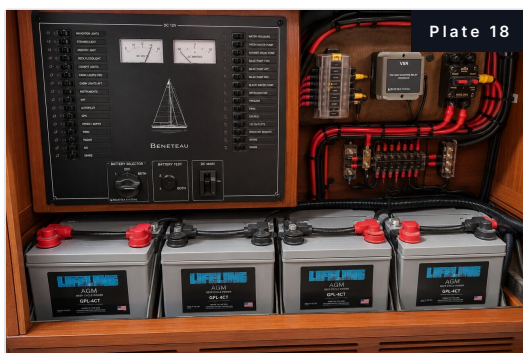
Plate 18. Main DC panel and AGM house bank; tidy, labelled, recently renewed.

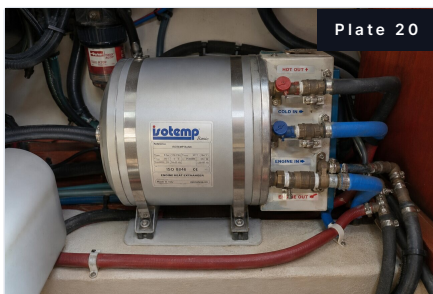
Plate 20. Calorifier and fresh-water manifold; serviceable, no leaks.

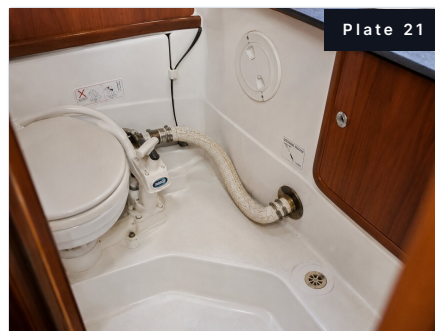
Two manual marine heads discharge to dedicated holding tanks with deck pump-out and overboard discharge through seacocks. The aft head and its hoses were odour-free and sound. The **forward** sanitation hose has permeated, producing a detectable odour, and the discharge hose is hardened — both due for replacement with current sanitation-grade hose. See Finding B-5. No active leaks were seen at visible tank surfaces.

Plate 21. Forward head; sanitation hose permeated and hardened (B-5).

| B-5 | Forward sanitation hose permeated; replace. |

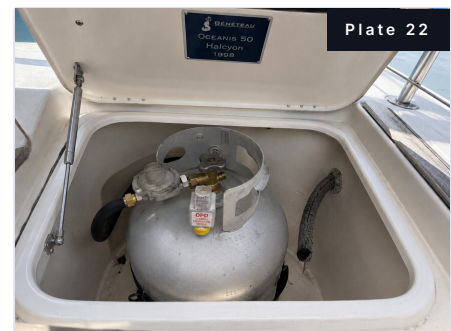
Plate 22. Vented propane locker; overboard drain hose deteriorated (A-2).

A single aluminium propane cylinder is housed in a dedicated top-opening, overboard-vented locker serving the galley stove, with a solenoid shut-off switched at the galley and a regulator at the cylinder. The cylinder is fitted with an overfill-protection device. The locker's **overboard drain hose is deteriorated and partially detached**, defeating the locker's purpose of venting heavier-than-air gas overboard; this is a safety item requiring correction. See Finding A-2.

| A-2 | Propane locker overboard drain hose deteriorated. |

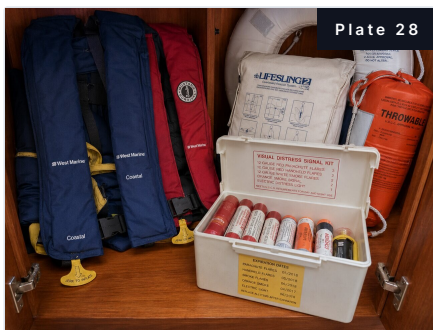
Wearable PFDs were aboard in adequate number with a throwable cushion and a horseshoe buoy with a floating light at the stern rail. Visual distress signals on board were **past their expiration date and insufficient in number** for a vessel of this length; current pyrotechnic or electronic signals must be carried. See Finding A-1. An EPIRB was not sighted and is recommended for offshore use.

Plate 28. Stowed PFDs and distress kit; flares expired (A-1).

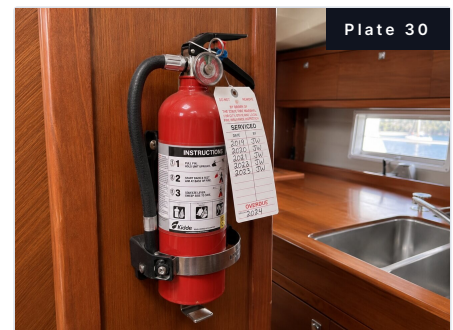
Portable dry-chemical extinguishers were mounted in the galley and accommodation areas; gauges read in the charged band, and tags indicate service is due. A fixed extinguishing system was not fitted to the engine space — recommended for inboard diesel installations. See Finding C-12.

Plate 30. Galley extinguisher; charged, service tag overdue (C-12).
